Willard A. Slade Building Hubbardston Town Offices

Assessment of Veneer Brick Deformation

May 2009

Investigation by Chenot Associates, Inc., Architects, with Bolton & DiMartino, Structural Engineers, into the cause and extent of severe deformation of veneer brick facing.

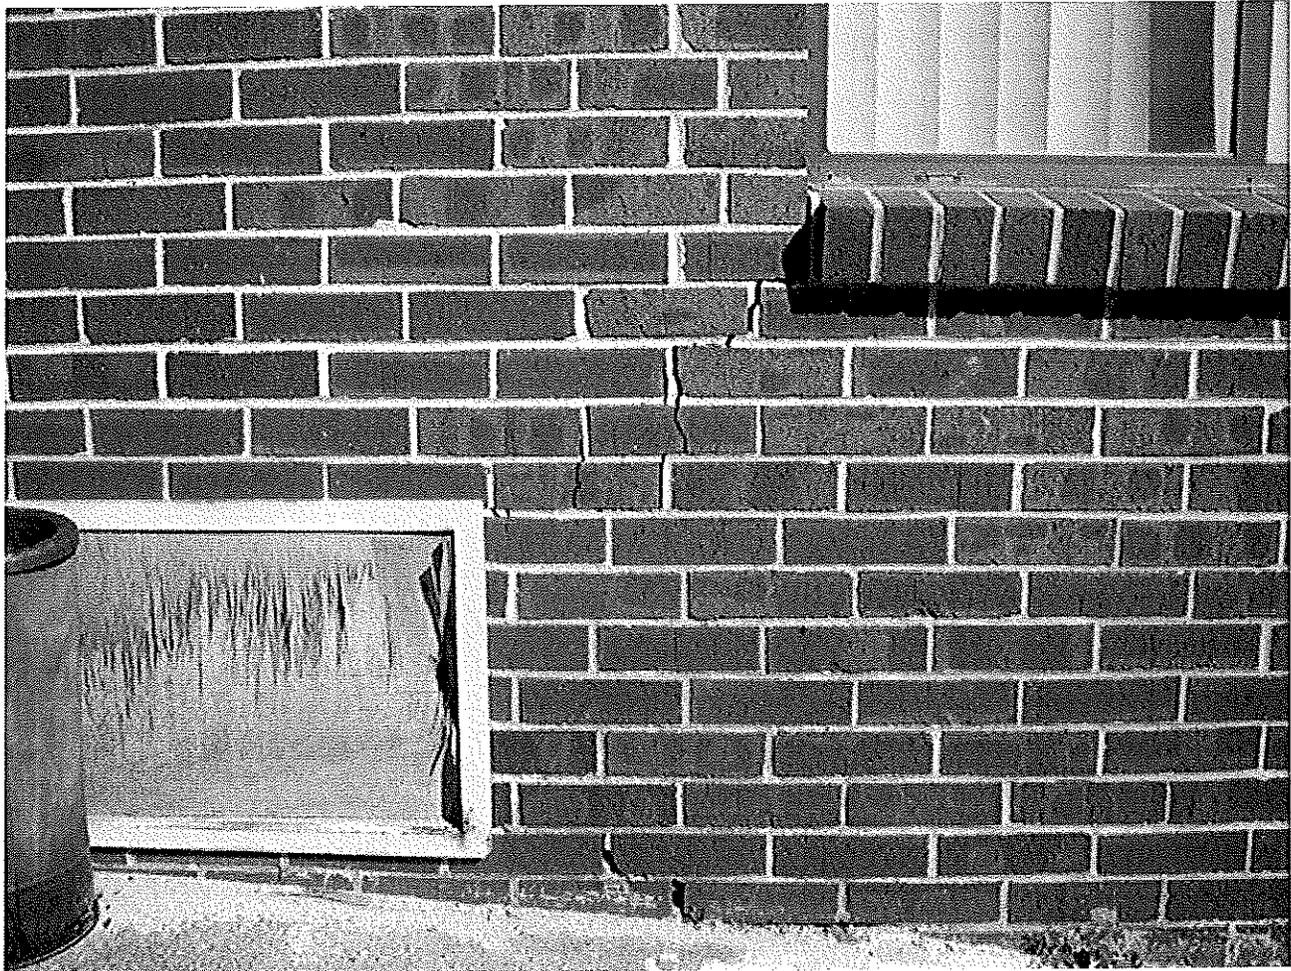
B1 8304
South wall at Police Department window.

Veneer brick has deformed to the right / eastward, opening the mortar joint at the sill, and a ladder crack down to the opening for an original classroom ventilator, removed and closed with plywood.

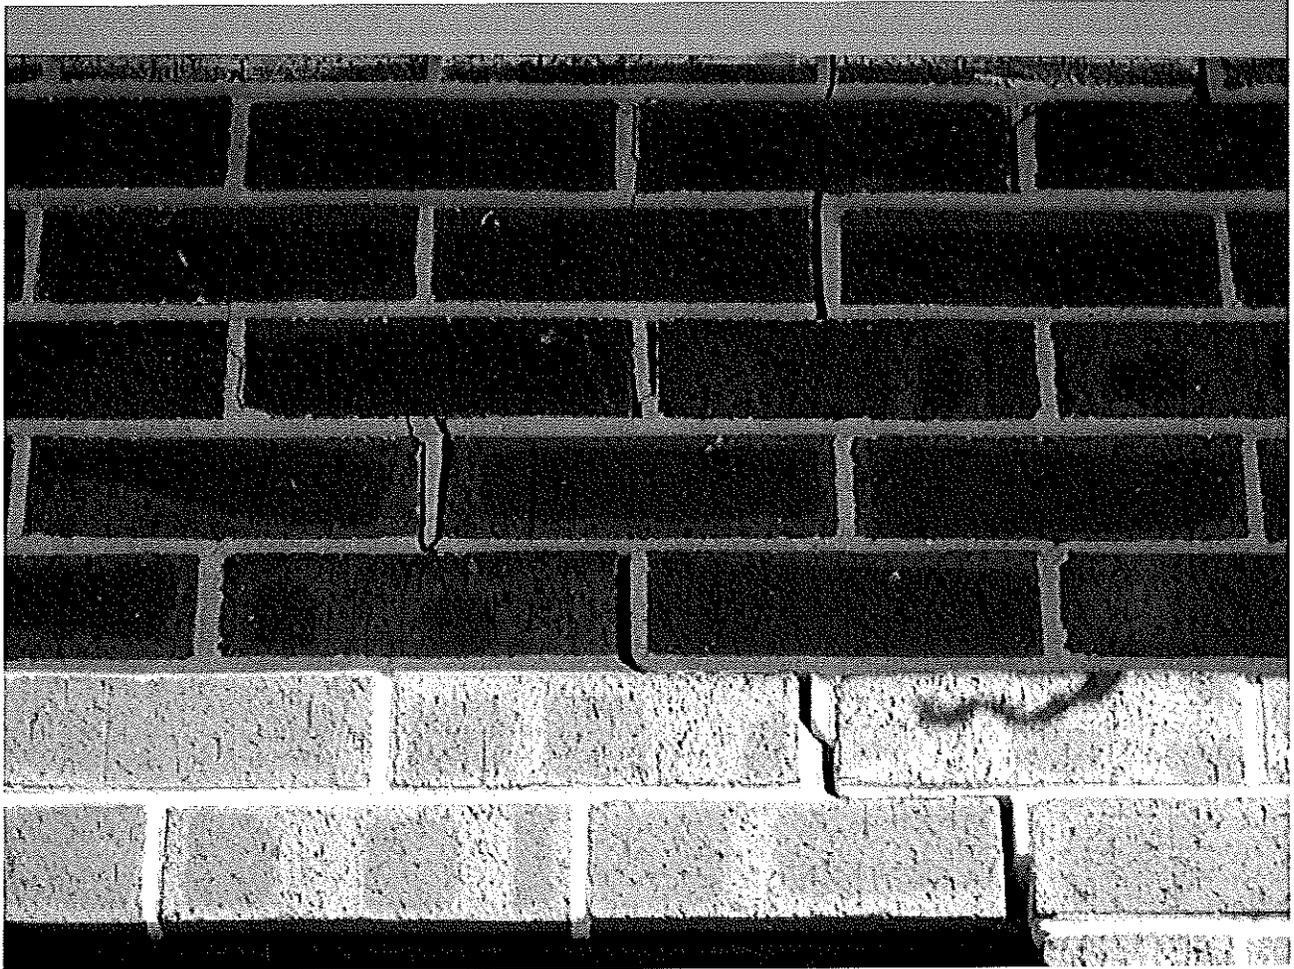
B2 8296
South wall at Police Department window.

Veneer brick has deformed to the right / eastward, opening the mortar joint at the window head, and a ladder crack up to the fascia trim.

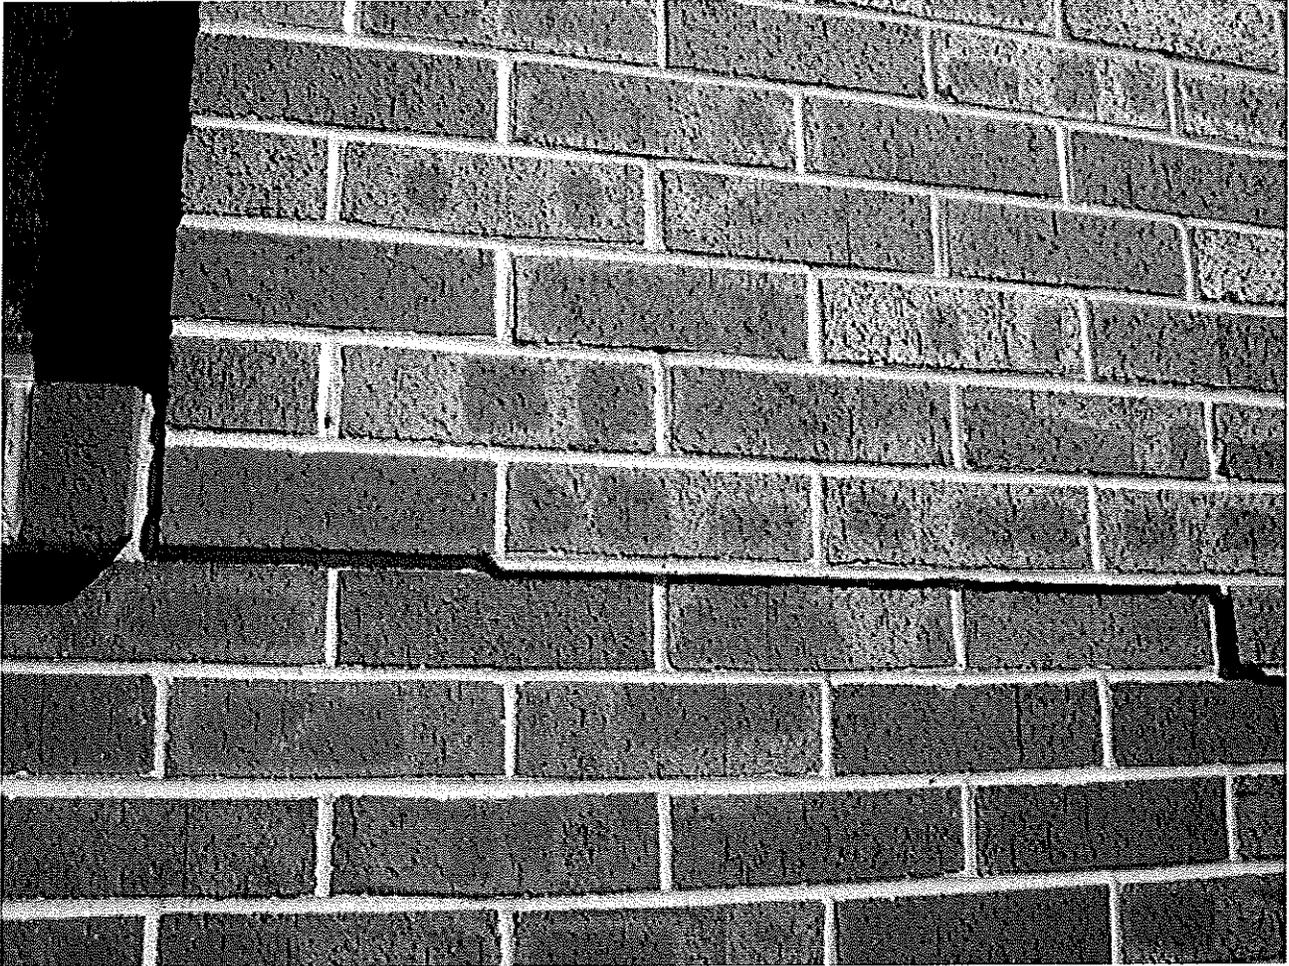
B3 8297

South wall at Police Department window.

Veneer brick has deformed to the right / eastward, opening the mortar joint at the window head, a horizontal crack to the right, and a ladder crack down to the southeast corner. The veneer panel above the crack has shifted outward about 3/8 inch.

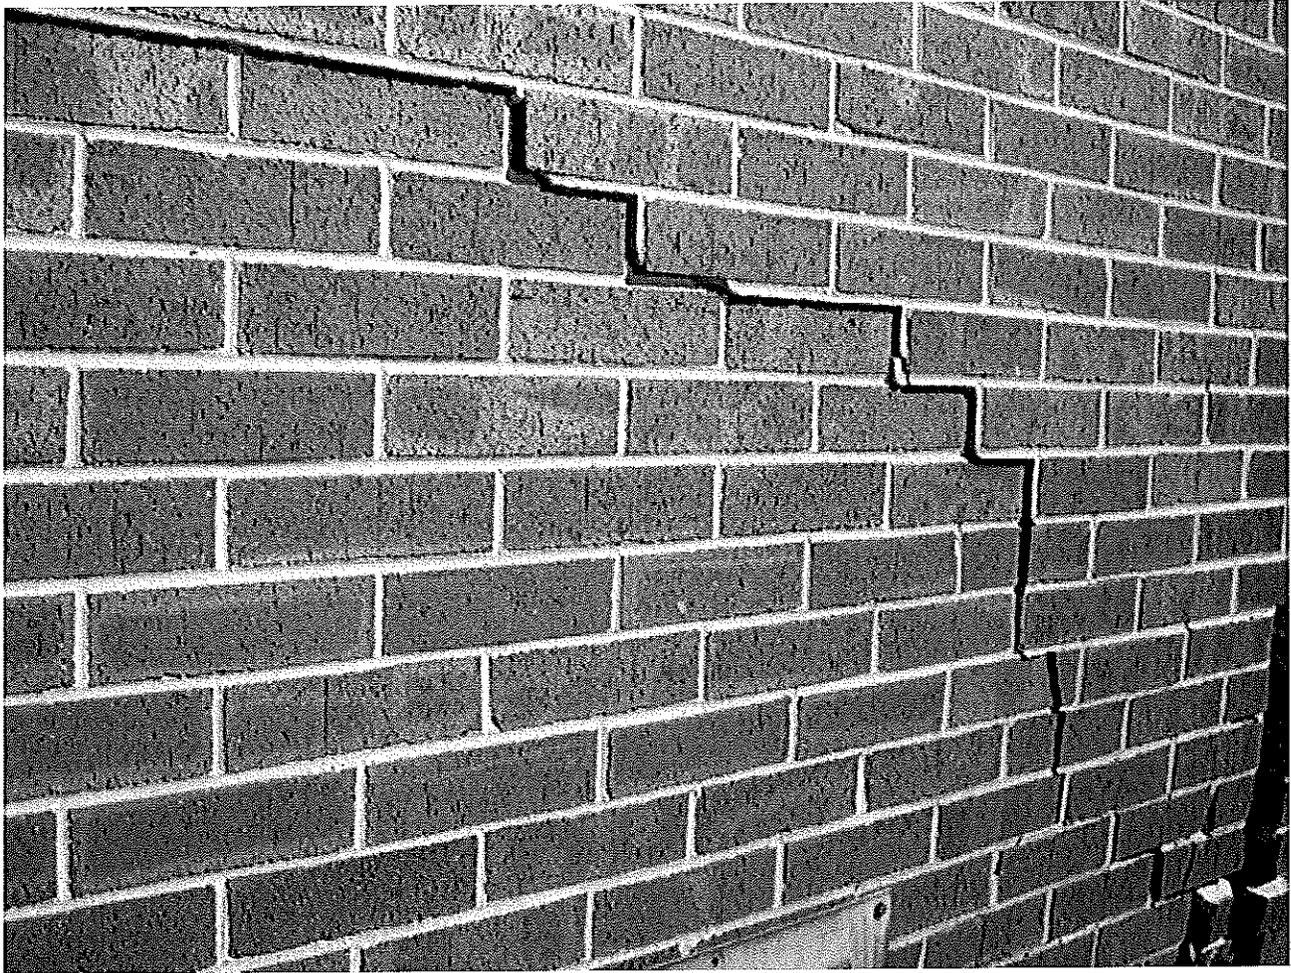
B4 8298
South wall east of Police Department window.

Veneer brick has deformed to the right / eastward, opening a ladder crack down to the southeast corner. The veneer panel above and right of the crack has shifted outward about 3/8 inch.

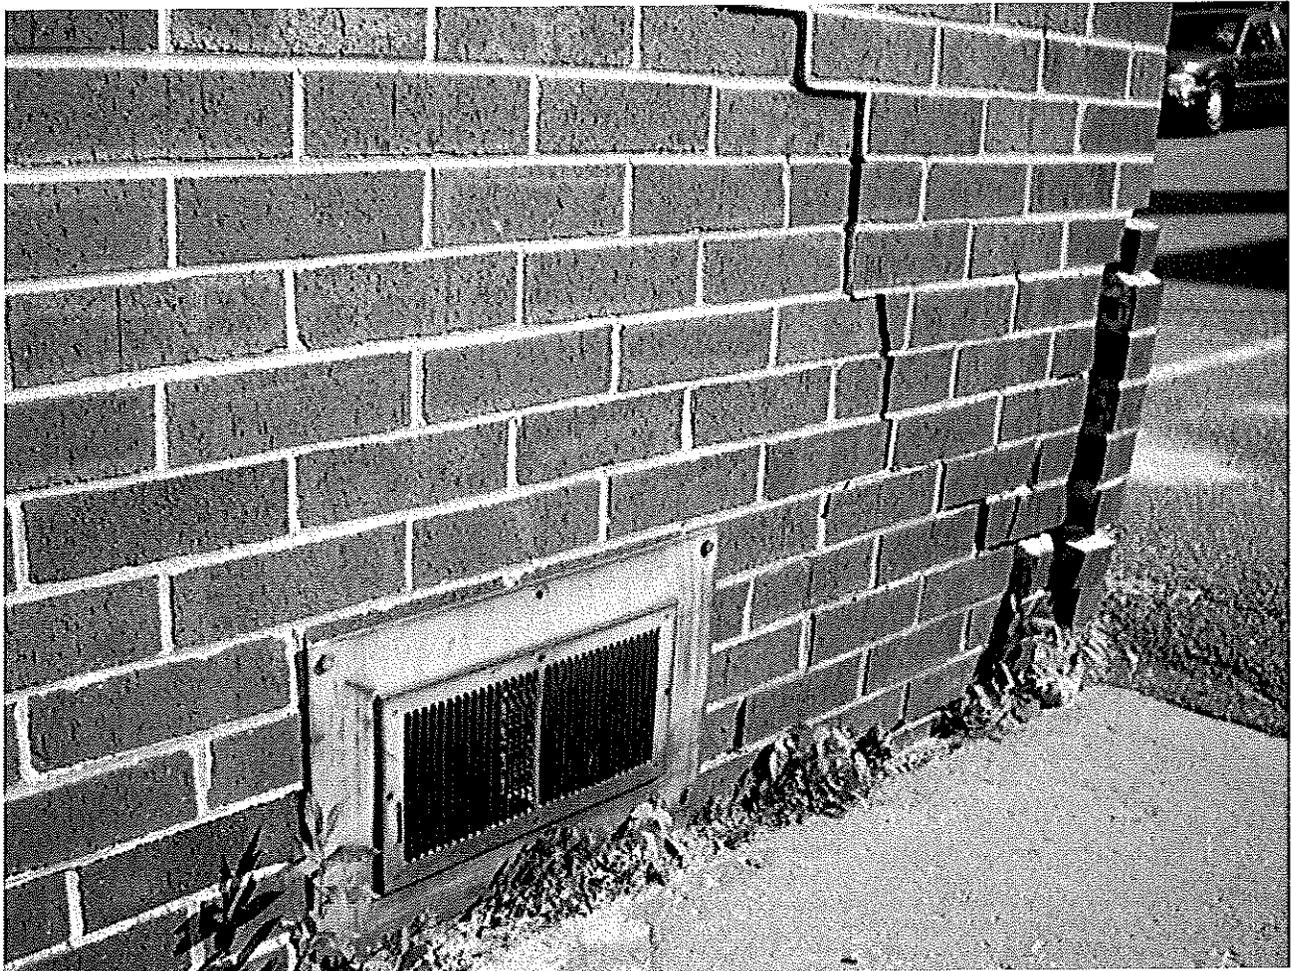
B5 8299
South wall east of Police Department window.

The ladder crack shown in previous photos extends down to the southeast corner. The veneer panel above and right of the crack has shifted outward, and the entire corner has separated.

Water from rain and snow melt enters the wall cavity through opened mortar joints and through weep joints intended to let cavity moisture out.

When ice builds up along the face of the building, water also enters the crawl space through the ventilator.

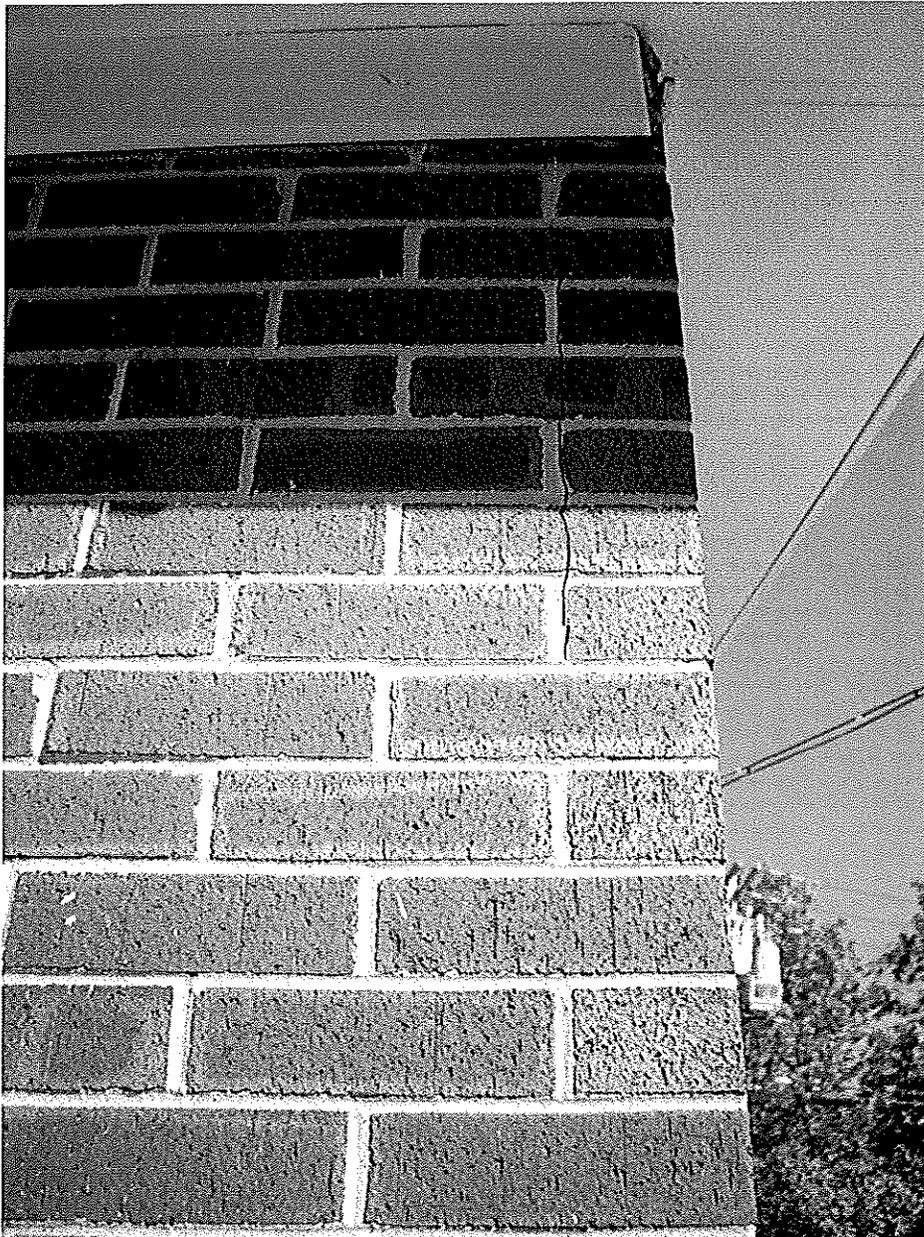
B5a 8302
South wall east of Police Department window.

A hairline shear crack extends down eight brick courses from the fascia trim.

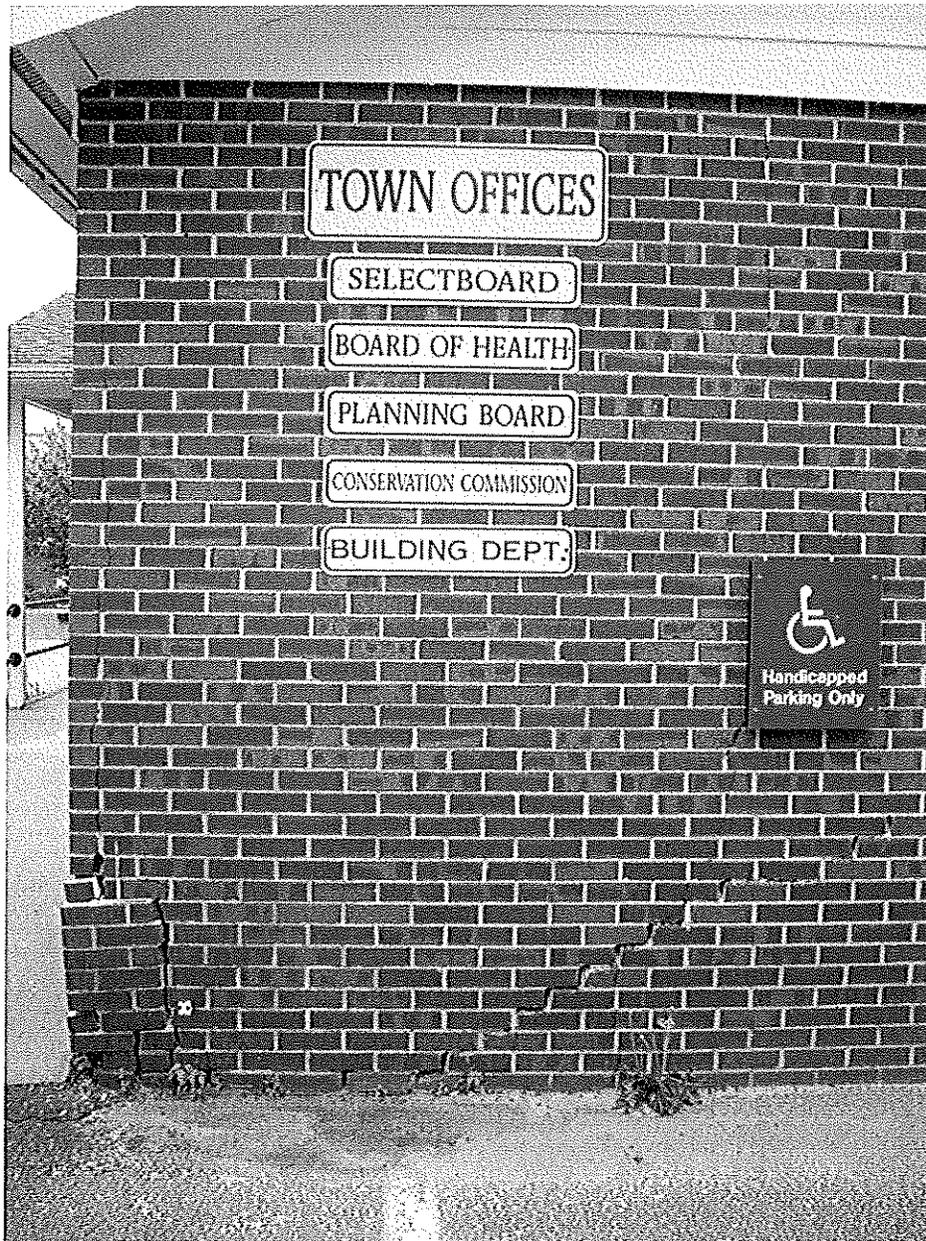
B6 8284
East wall at southeast corner.

South ramp is at left. At the base of the wall the entire veneer brick corner has separated. One brick to the right of the weep joint, a ladder crack extends upward beyond the parking sign. At the lower left of the parking sign is the bottom of a hairline shear crack that extends vertically up to the fascia trim.

The pavement is placed too high, covering the entire foundation. Water from rain and snow melt enters the wall cavity through opened mortar joints and through weep joints intended to let cavity moisture out.

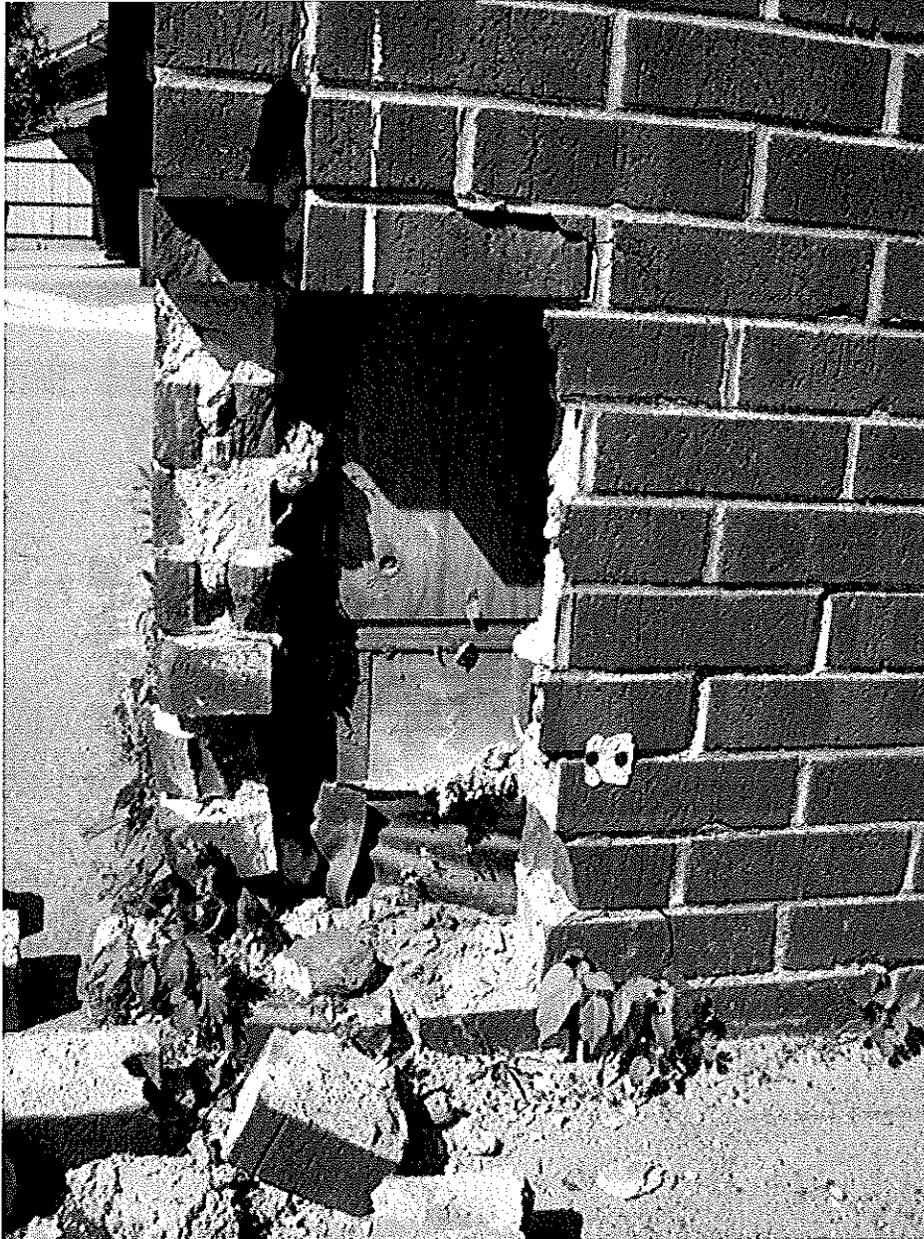
B7 8328
East wall at southeast corner.

South ramp is at left. At the base of the wall the entire veneer brick corner has separated, removed for this photo. The band joist shows water staining. The black through-wall flashing is intended to carry minor condensation within the cavity out through weep joints in the base course.

The pavement is placed too high, covering the entire foundation. Water from rain and snow melt enters the wall cavity through opened mortar joints and through weep joints intended to let cavity moisture out. A fragment of downspout strap indicates previous gutter discharge here.

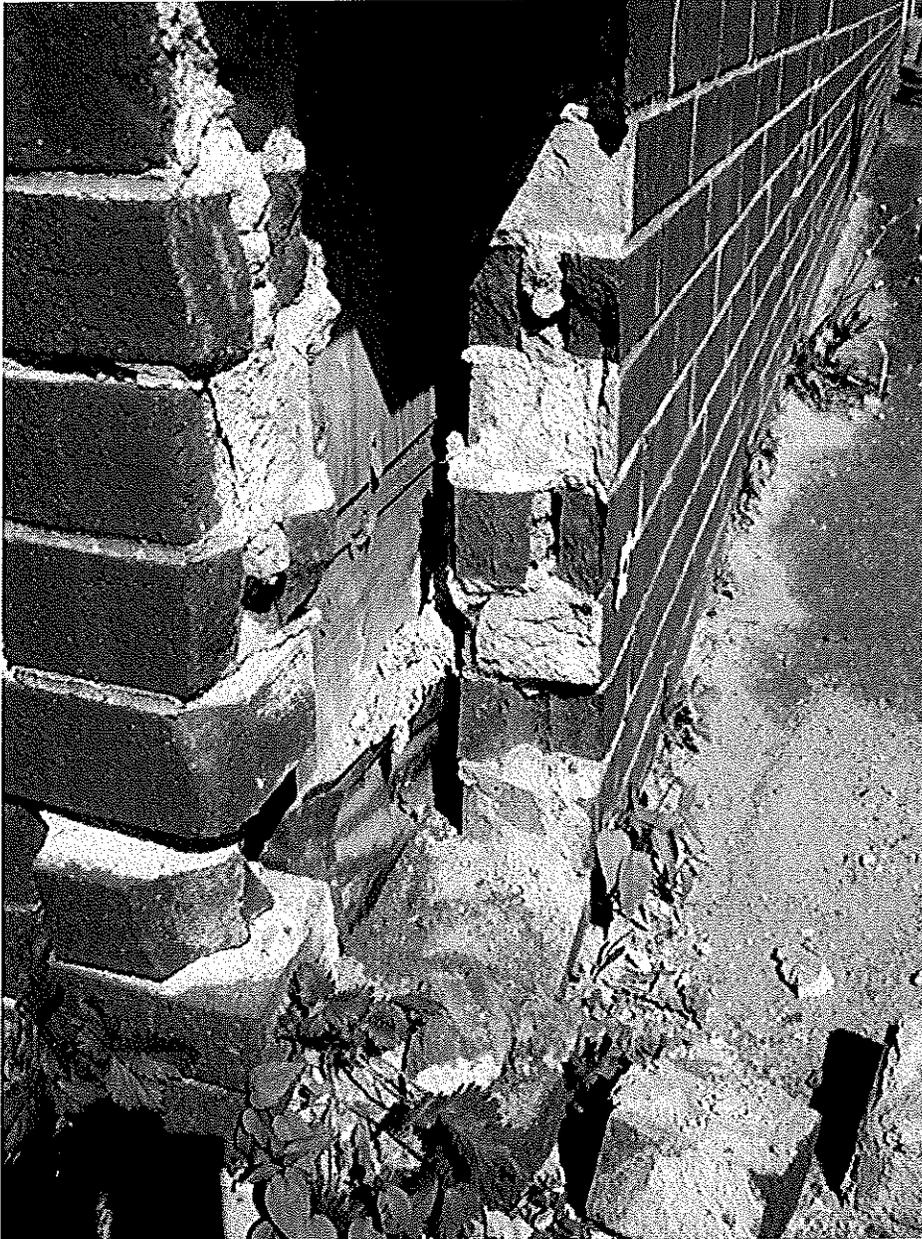
B8 8329
Southeast corner.

Looking along the front of the building. At the base of the wall the entire veneer brick corner has separated, removed for this photo. The band joist shows water staining. The black through-wall flashing is intended to carry minor condensation within the cavity out through weep joints in the base course. The base of the veneer cavity has filled with sand, visibly retaining moisture.

The pavement is placed too high, covering the entire foundation. Water from rain and snow melt enters the wall cavity through opened mortar joints and through weep joints intended to let cavity moisture out.

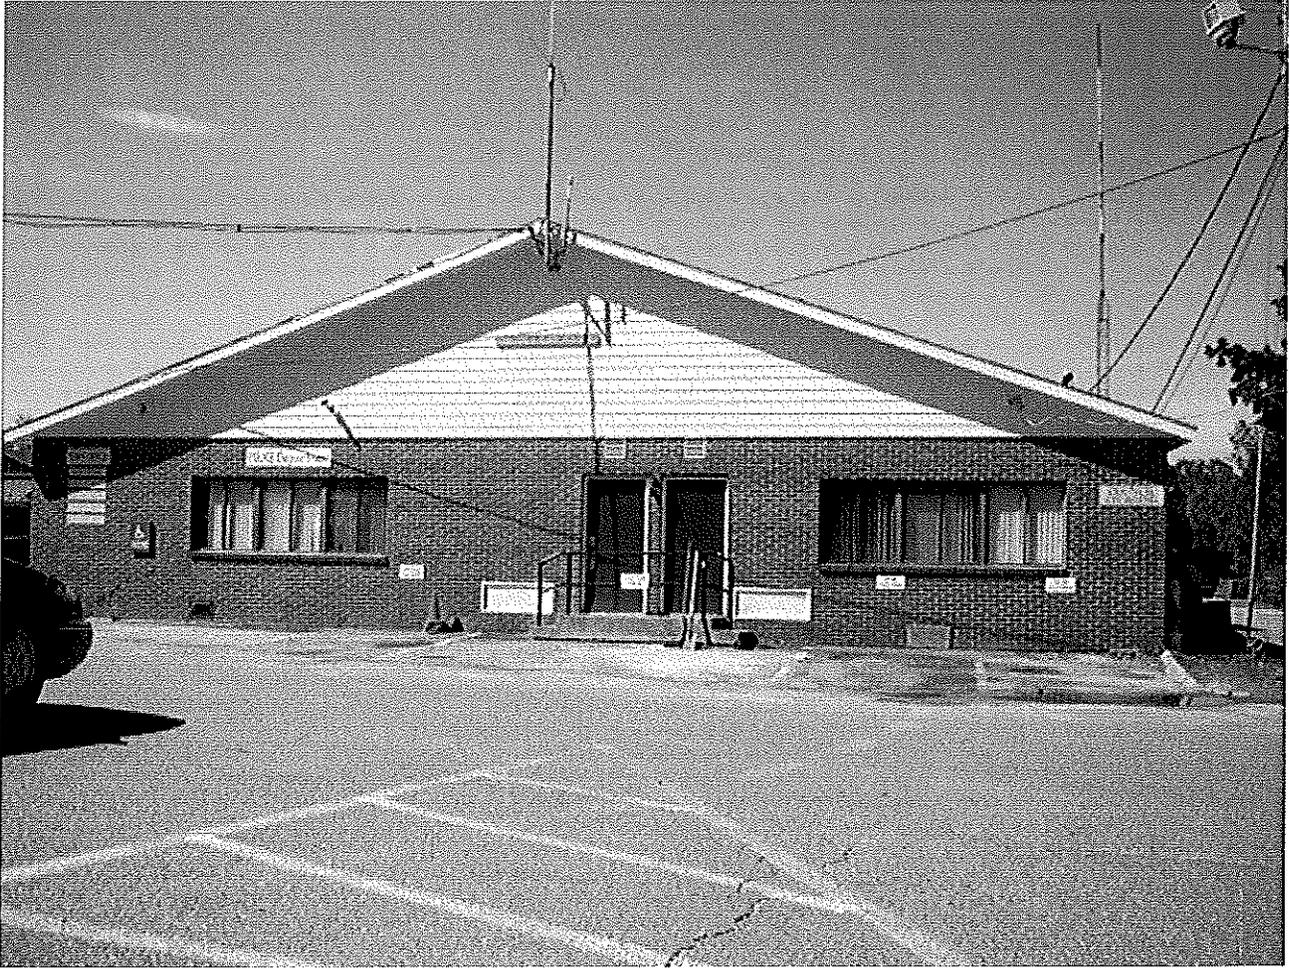
B9 8331
East elevation.

The pavement is placed too high, covering the entire foundation along the face of the building. Water from rain and snow melt enters the wall cavity through opened mortar joints and through weep joints intended to let cavity moisture out.

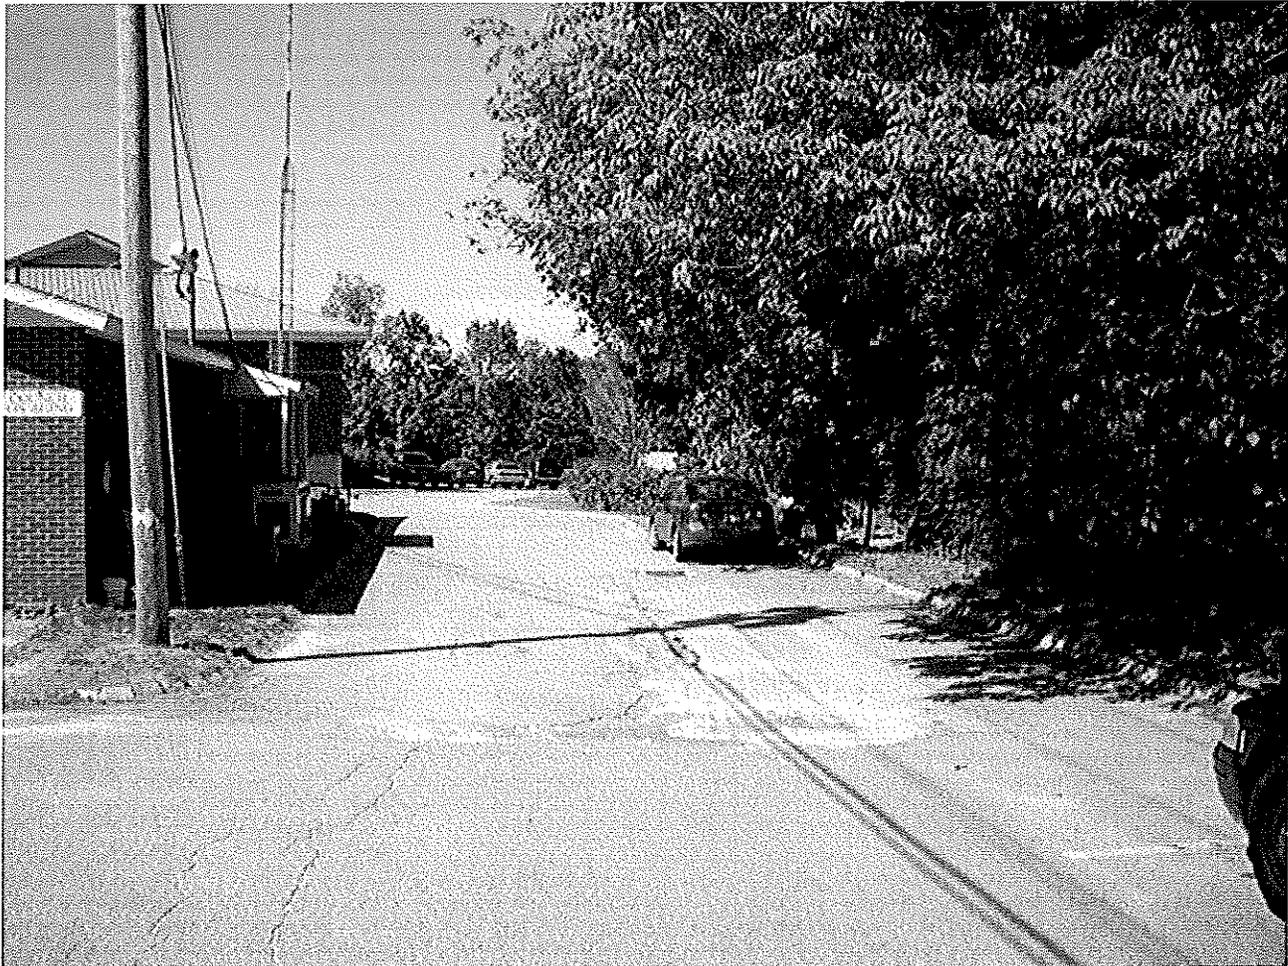
B10 8334
North driveway.

The pavement is graded to direct surface runoff northward and down the driveway to a catch basin at the left corner of the parked car.

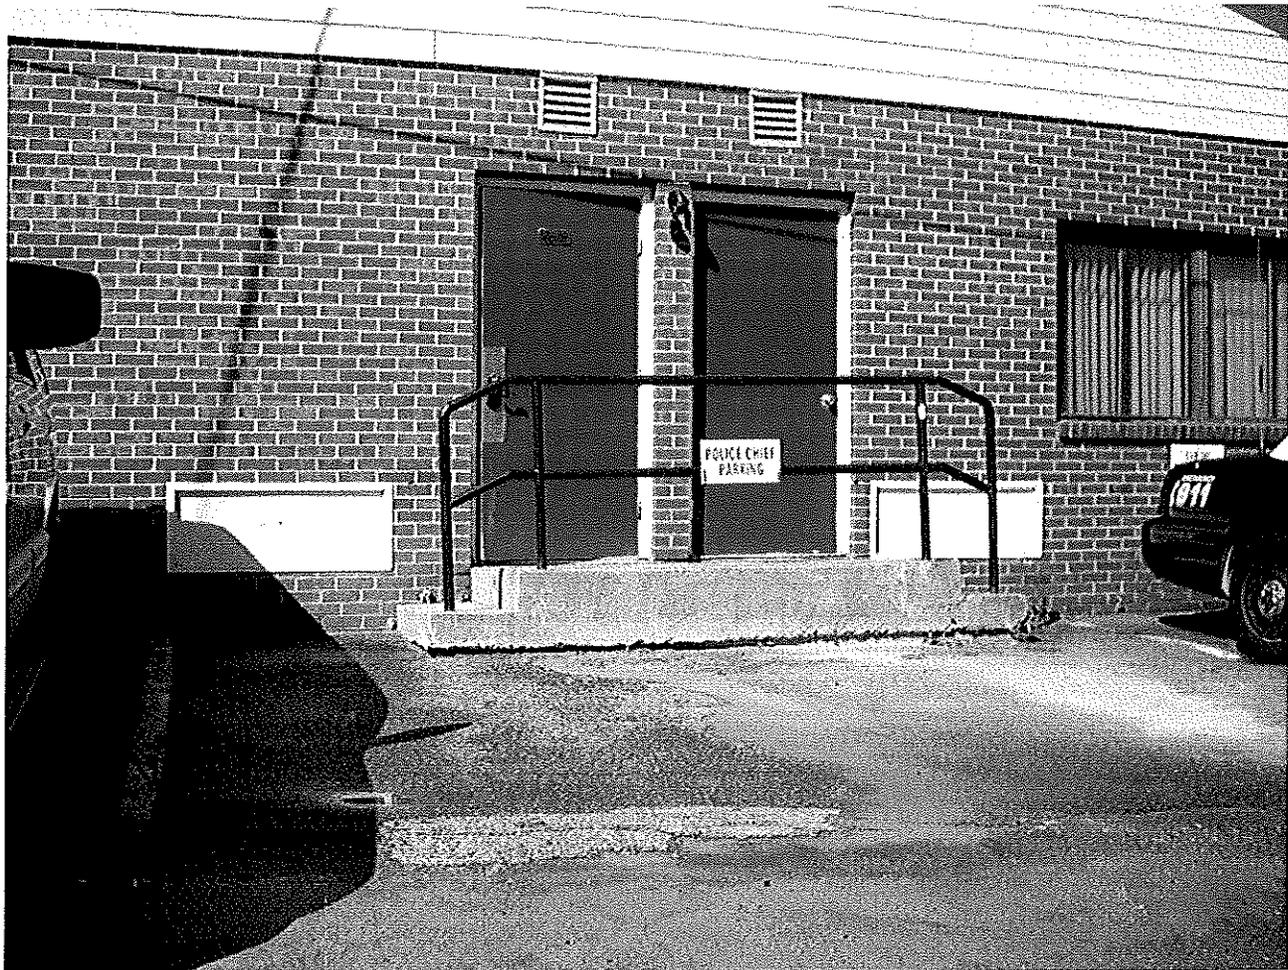
B11 8306
Police Department steps and landing.

Landing was constructed with no step at the door, so the original clearance for door swing was only the height of the threshold, about one inch.

1973 plans show a foundation and footing for the steps and landing. Either it was not built, or was not built to full depth, so the entire concrete mass of steps and landing has been lifted by freeze-thaw each season.

Result of these two deficiencies is that the Police Department doors now won't open more than eight inches in the peak of a severe winter. Each year when warm weather returns the deformation does not return completely to the pre-winter position, but remains worse, increasing the slope of the landing toward the building and causing water to pass between the concrete and the brick.

Replace the steps and landing at the Police Department doors with either concrete or pressure-treated wood, with steps exiting straight out rather than parallel to the building as now configured.

Set top of the new landing 6" below the threshold. Pitch 1/8" per foot away from the building.

If concrete, form to span the new drainage swale. Provide an adequate foundation wall and footing, and a 10" space between the building wall and the back of the new concrete. Bridge the short space with pressure-treated wood for air circulation and control of surface water.

For weather protection, add a gable canopy fully covering the steps and landing.

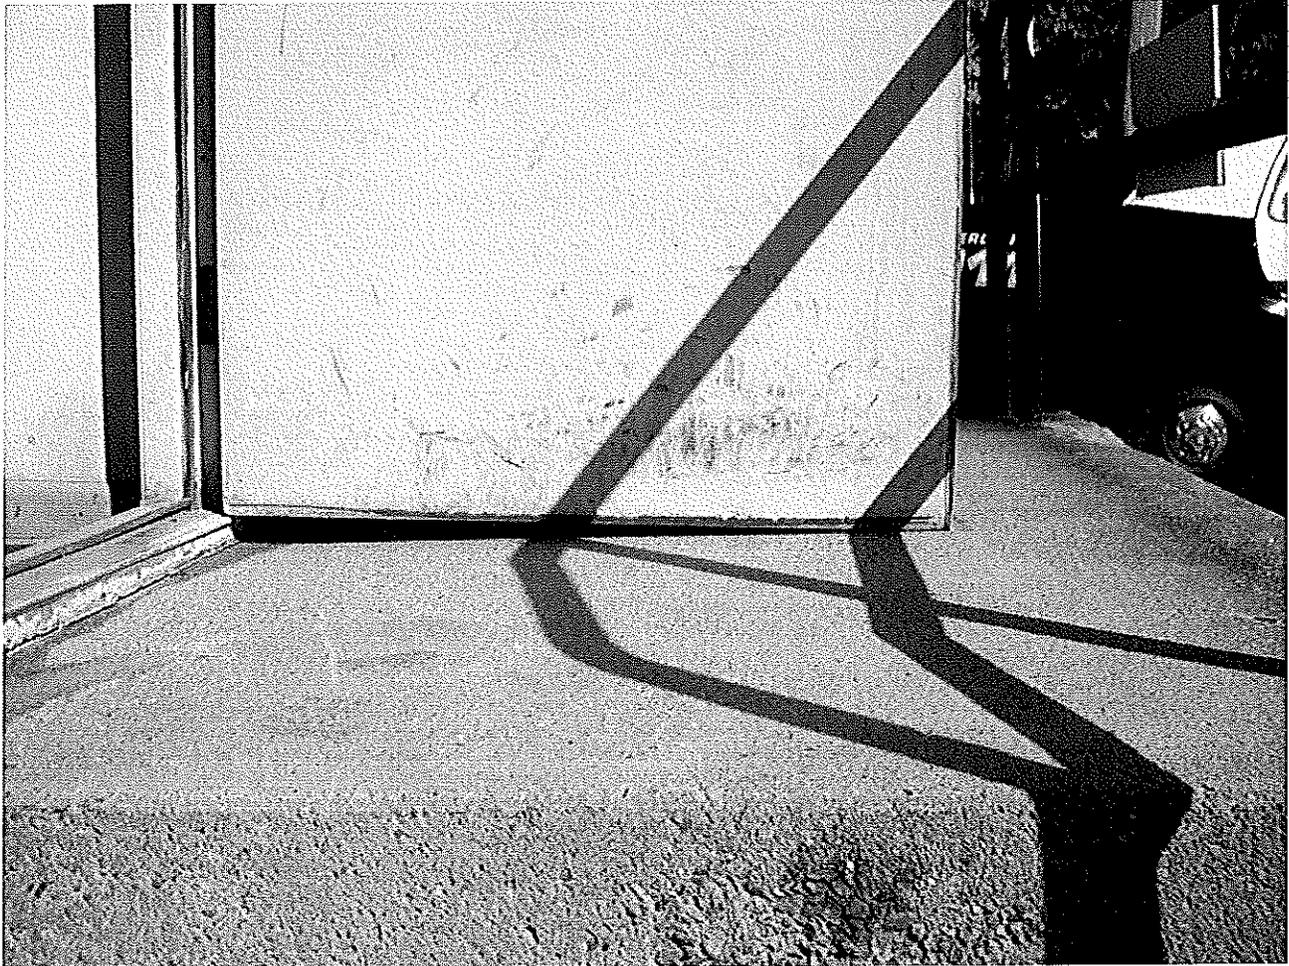
B12 8307
Police Department doors bind at landing.

Landing was constructed with no step at the door, so the original clearance for door swing was only the height of the threshold, about one inch.

1973 plans show a foundation and footing for the steps and landing. Either it was not built, or was not built to full depth, so the entire concrete mass of steps and landing has been lifted by freeze-thaw each season.

Result of these two deficiencies is that the Police Department doors now won't open more than eight inches in the peak of a severe winter. Each year when warm weather returns the deformation does not return completely to the pre-winter position, but remains worse, increasing the slope of the landing toward the building and causing water to pass between the concrete and the brick. Trapped water causes freeze-thaw deformation in the veneer brick surrounding the landing.

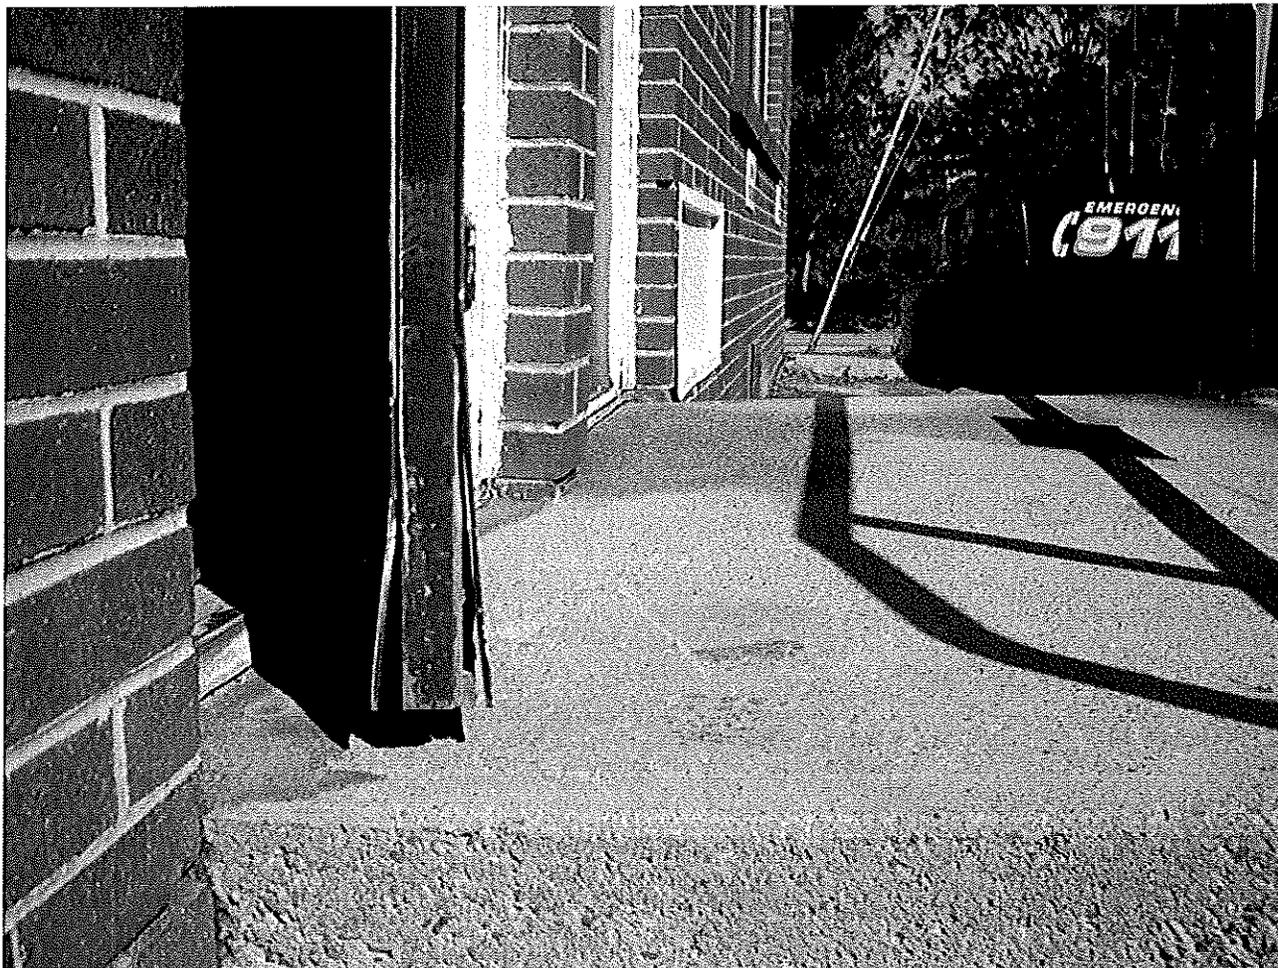
B13 8308
Police Department doors delaminated.

Landing was constructed with no step at the door, so the original clearance for door swing was only the height of the threshold, about one inch.

There is no canopy above the landing, for weather protection. Both doors have delaminated from constant exposure.

Years of freeze-thaw cycle have sloped the landing toward the building, causing water to pass between the concrete and the brick. Trapped water causes freeze-thaw deformation in the veneer brick surrounding the landing.

Remove both Police Department doors. Install pan flashing for a watertight seal at the new door thresholds. Install two new Police Department doors, insulated galvanized steel

commercial grade exterior doors.

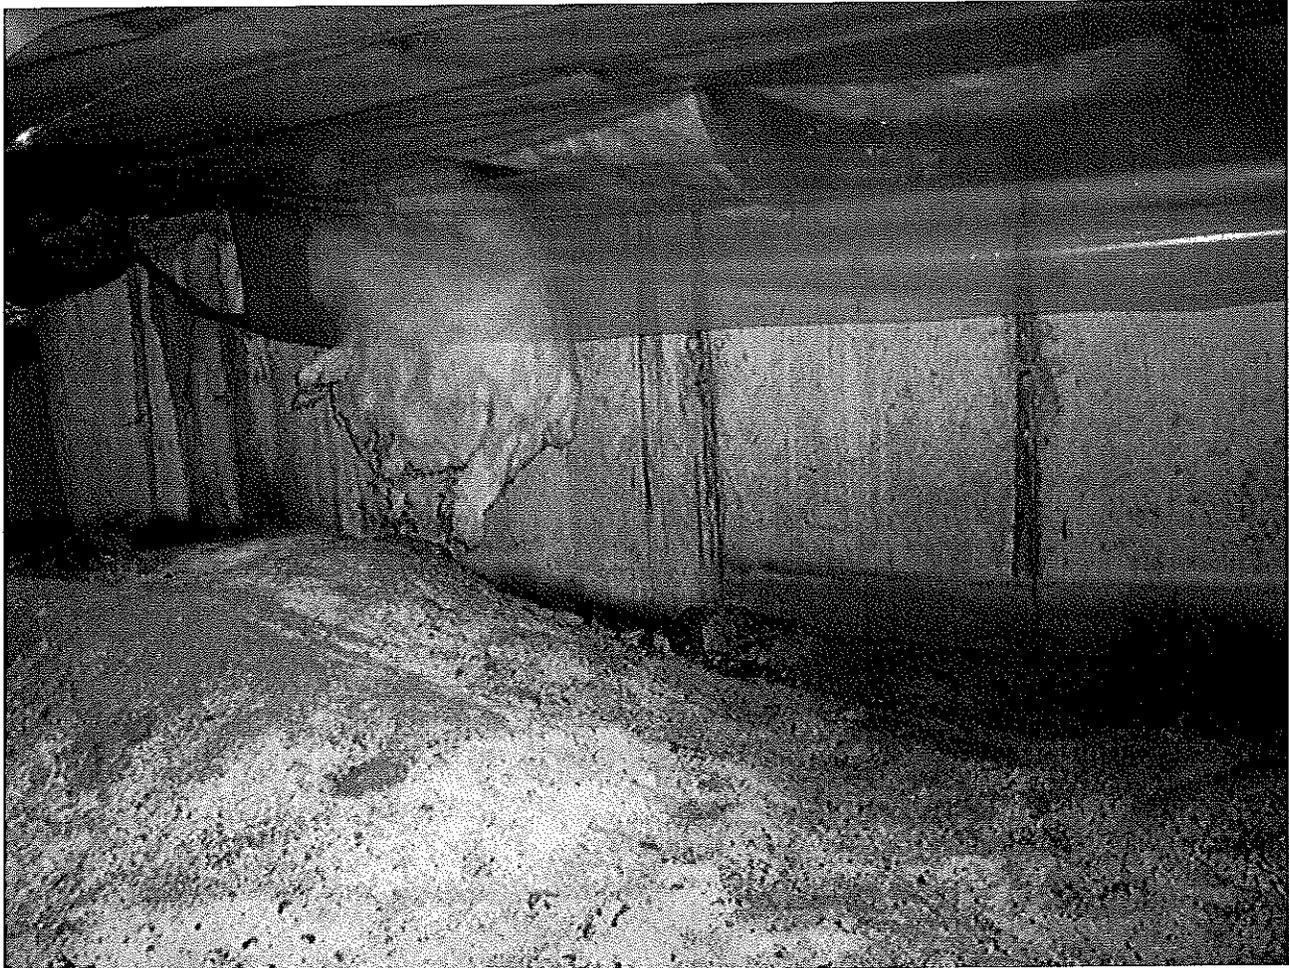
1 8313

South wall from the southeast corner at extreme left.

Vertical stain near the left corner is from water and snow-melt salt entering through the south crawl space vent.

4 mil poly stapled to joists is hanging, with insulation, possibly pulled down in a previous investigation of water damage.

Foundation wall at footing shows wetness from heavy rain five days ago, and stain from seasonal standing water.

White mold is on all exposed earth not covered by 4 mil poly ground moisture barrier.

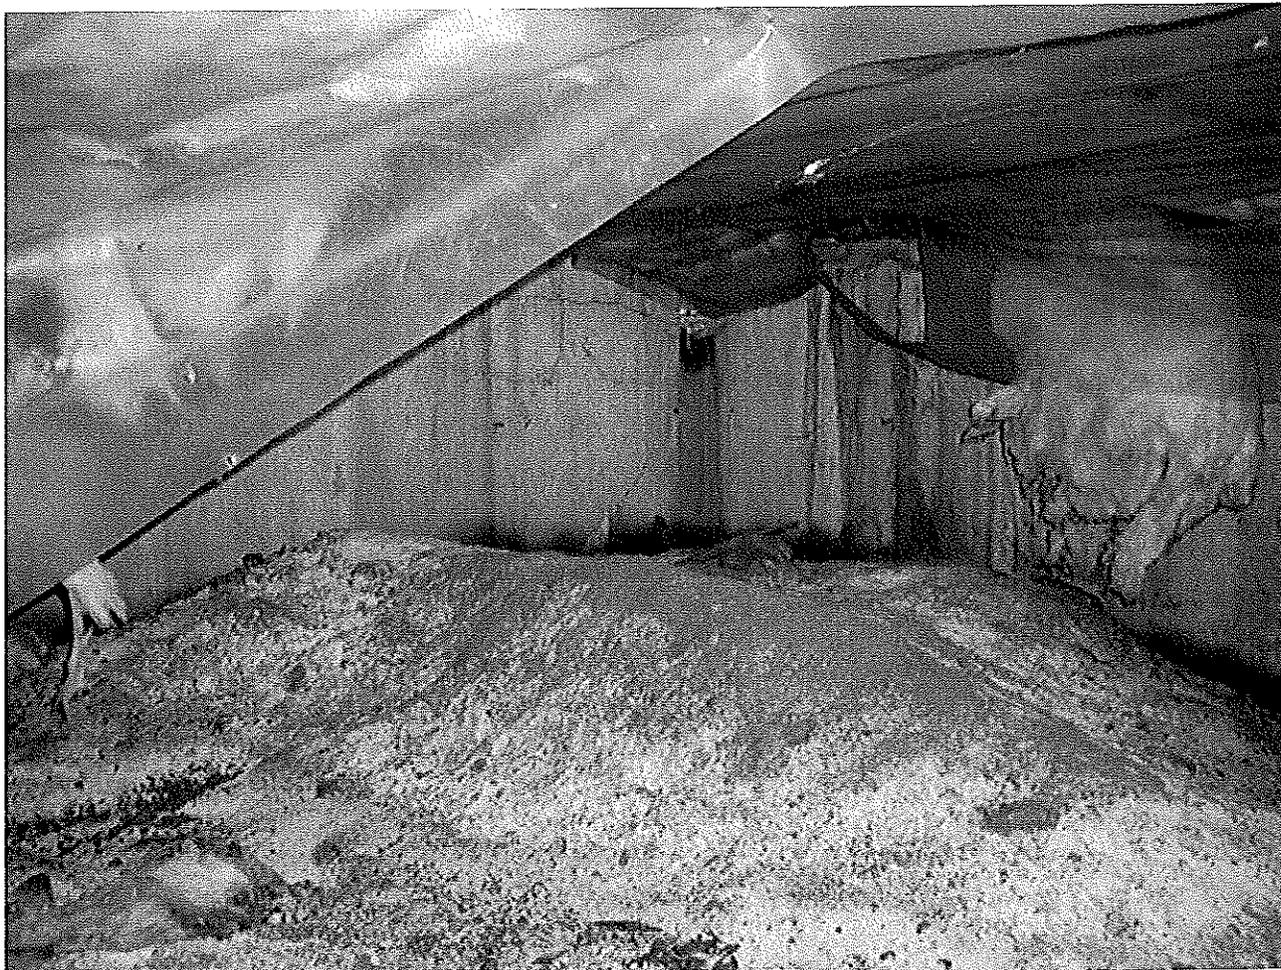
2 8312
Southeast corner.

Note horizontal crack on the east / front wall. Other lines are cobwebs.

Also note diagonal crack angling downward from the wet stain at the low point of the horizontal crack.

Vertical stain on the south / ramp entrance wall to right of the corner is from water and snow-melt salt entering through the south crawl space vent.

Foundation wall at footing shows wetness from heavy rain five days ago, and stain from seasonal standing water.

4 mil poly stapled to joists is hanging, with insulation, possibly pulled down in a previous investigation of water damage.

White mold is on all exposed earth not covered by 4 mil poly ground moisture barrier.
