Willard A. Slade Building Hubbardston Town Offices

Assessment of Veneer Brick Deformation

May 2009

Investigation by Chenot Associates, Inc., Architects, with Bolton & DiMartino, Structural Engineers, into the cause and extent of severe deformation of veneer brick facing.

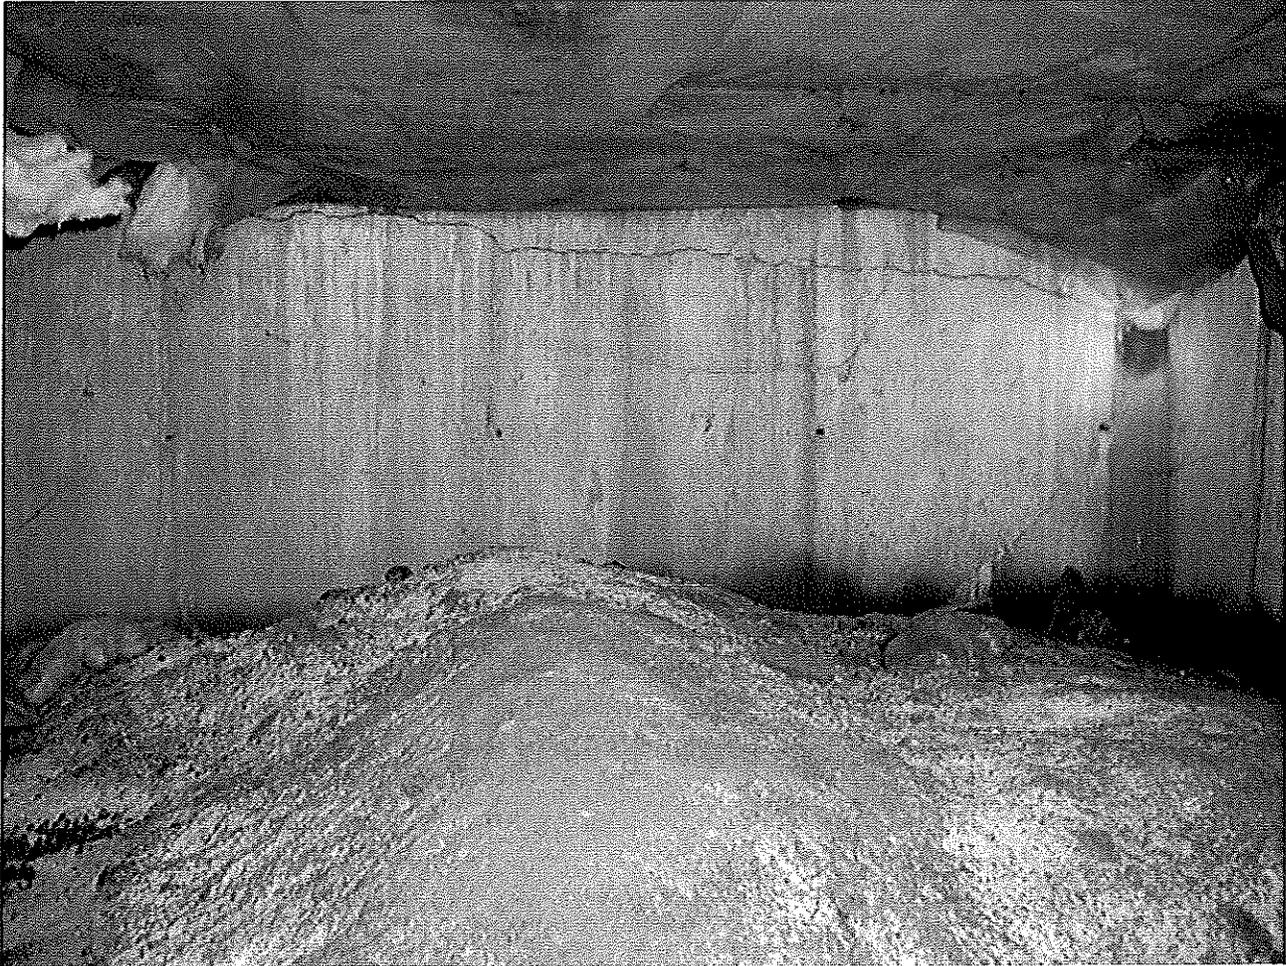
3 8318
East / front wall at the southeast corner.

Note horizontal crack on the east wall. Other lines are cobwebs.

Also note diagonal crack angling downward from the wet stain at the low point of the horizontal crack.

Foundation wall at footing shows wetness from heavy rain five days ago, and stain from seasonal standing water.

4 mil poly stapled to joists is hanging, with insulation, possibly pulled down in a previous investigation of water damage.

White mold is on all exposed earth not covered by 4 mil poly ground moisture barrier.

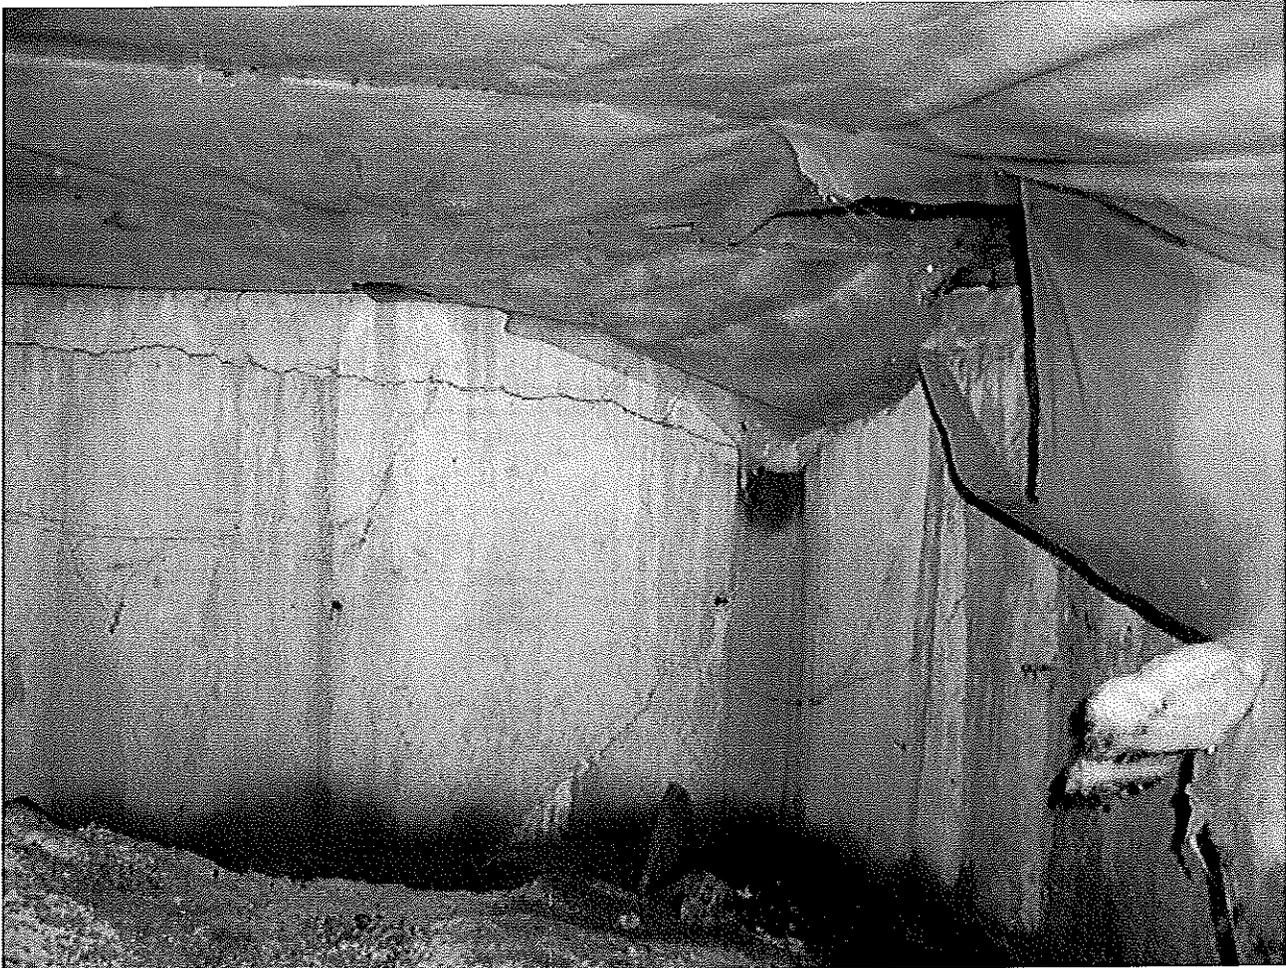
4 8319
East / front wall at the southeast corner.

Note horizontal cracking on the east wall AND south wall. Other lines are cobwebs. Also note diagonal crack angling upward from the east wall horizontal crack, and the diagonal crack angling downward from the wet stain at the low point of the east wall horizontal crack.

Vertical stain on the south wall to right of the corner is from water and snow-melt salt entering through the south crawl space vent and the foundation crack. Joist end visible above the south wall crack is water-stained.

Foundation wall at footing shows wetness from heavy rain five days ago, and stain from seasonal standing water.

4 mil poly stapled to joists is hanging, with insulation, possibly pulled down in a previous investigation of water damage.

White mold is on all exposed earth not covered by 4 mil poly ground moisture barrier.

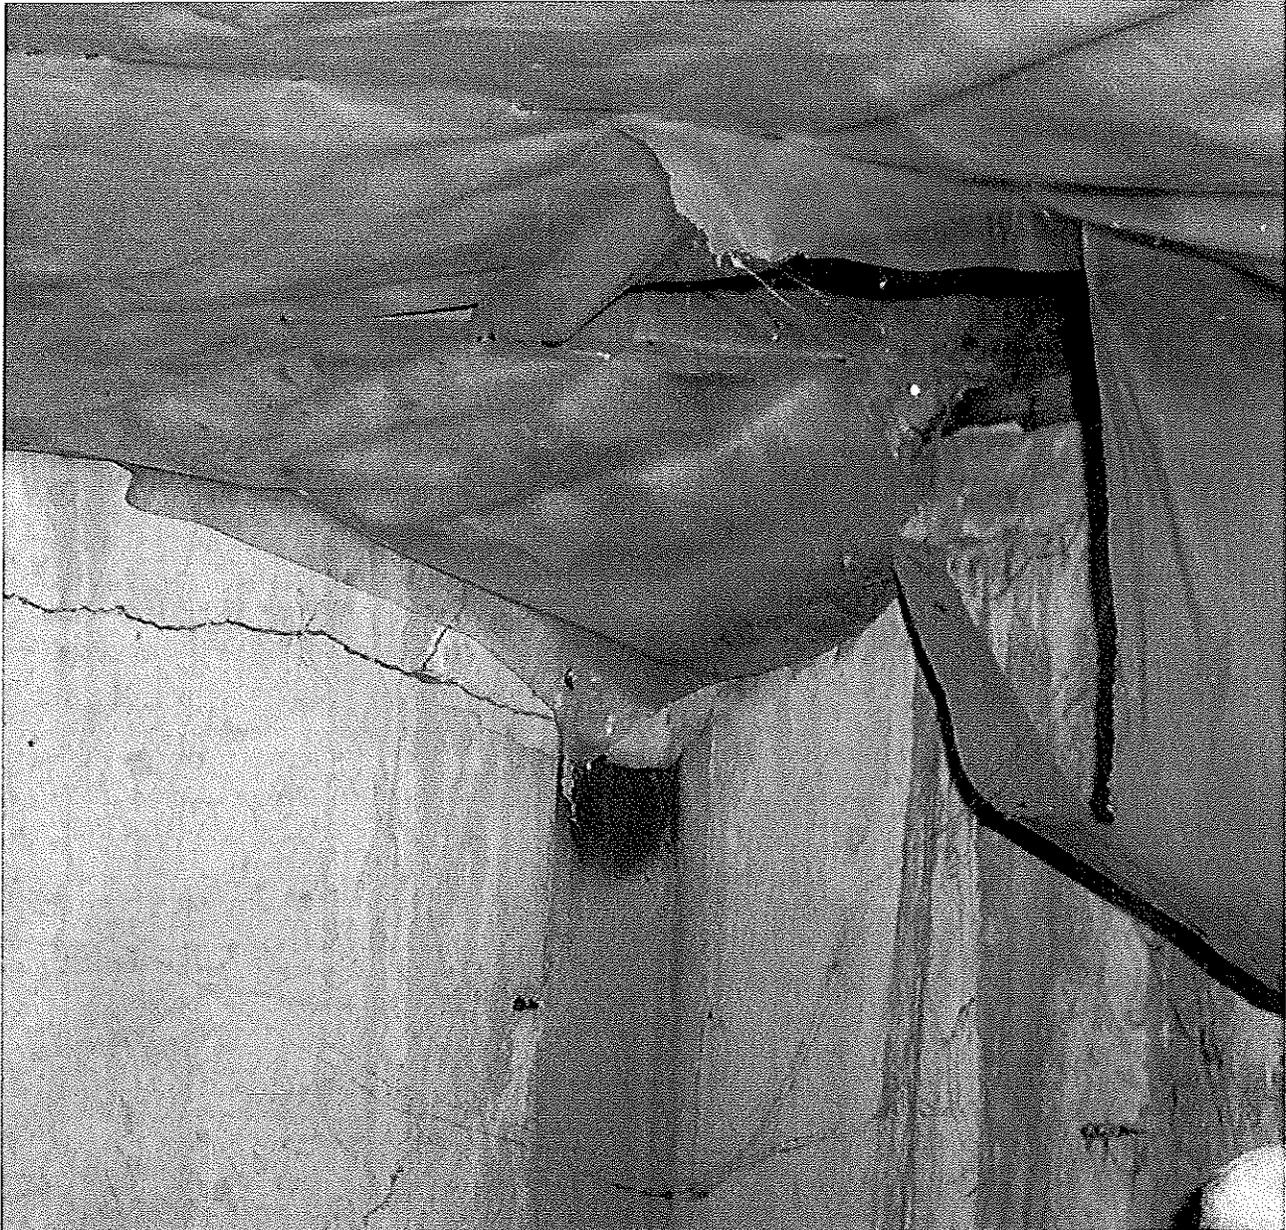
4 8319 detail
East / front wall at the southeast corner.

Note horizontal cracking on the east wall AND south wall. Other lines are cobwebs. Also note diagonal crack angling upward from the east wall horizontal crack, and the diagonal crack angling downward from the wet stain at the low point of the east wall horizontal crack.

Vertical stain on the south wall to right of the corner is from water and snow-melt salt entering through the south crawl space vent and the foundation crack. Joist end visible above the south wall crack is water-stained.

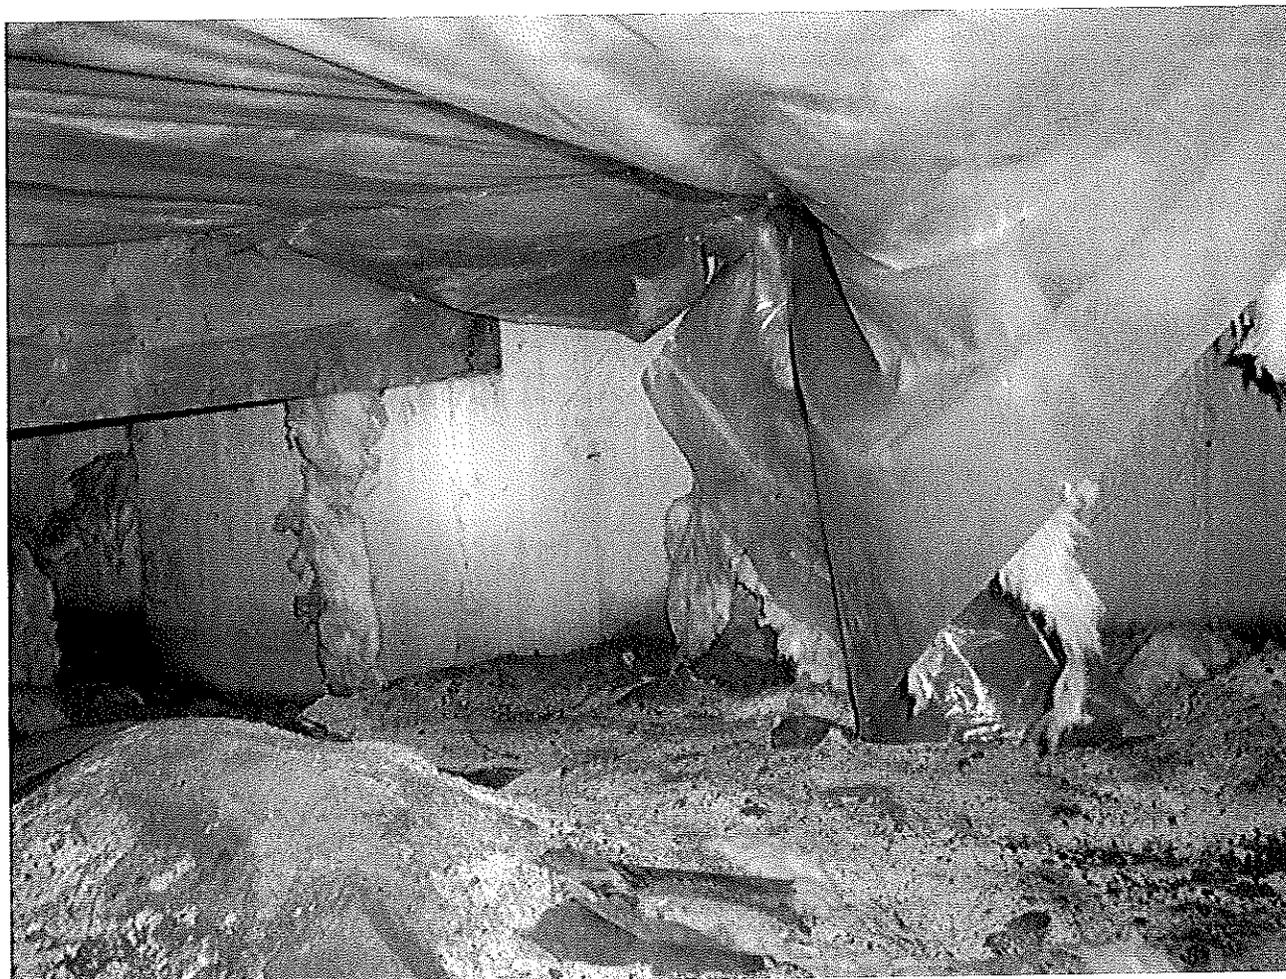
5 8320

East wall to left of the southeast corner, at the first beam pocket.

There appears to be a vertical crack from the left side of the beam pocket down to the footing. Beam end shows water staining.

Foundation wall at footing shows wetness from heavy rain five days ago.

White mold is on all exposed earth not covered by 4 mil poly ground moisture barrier.

4 mil poly stapled to joists is hanging, with insulation, possibly pulled down in a previous investigation of water damage.

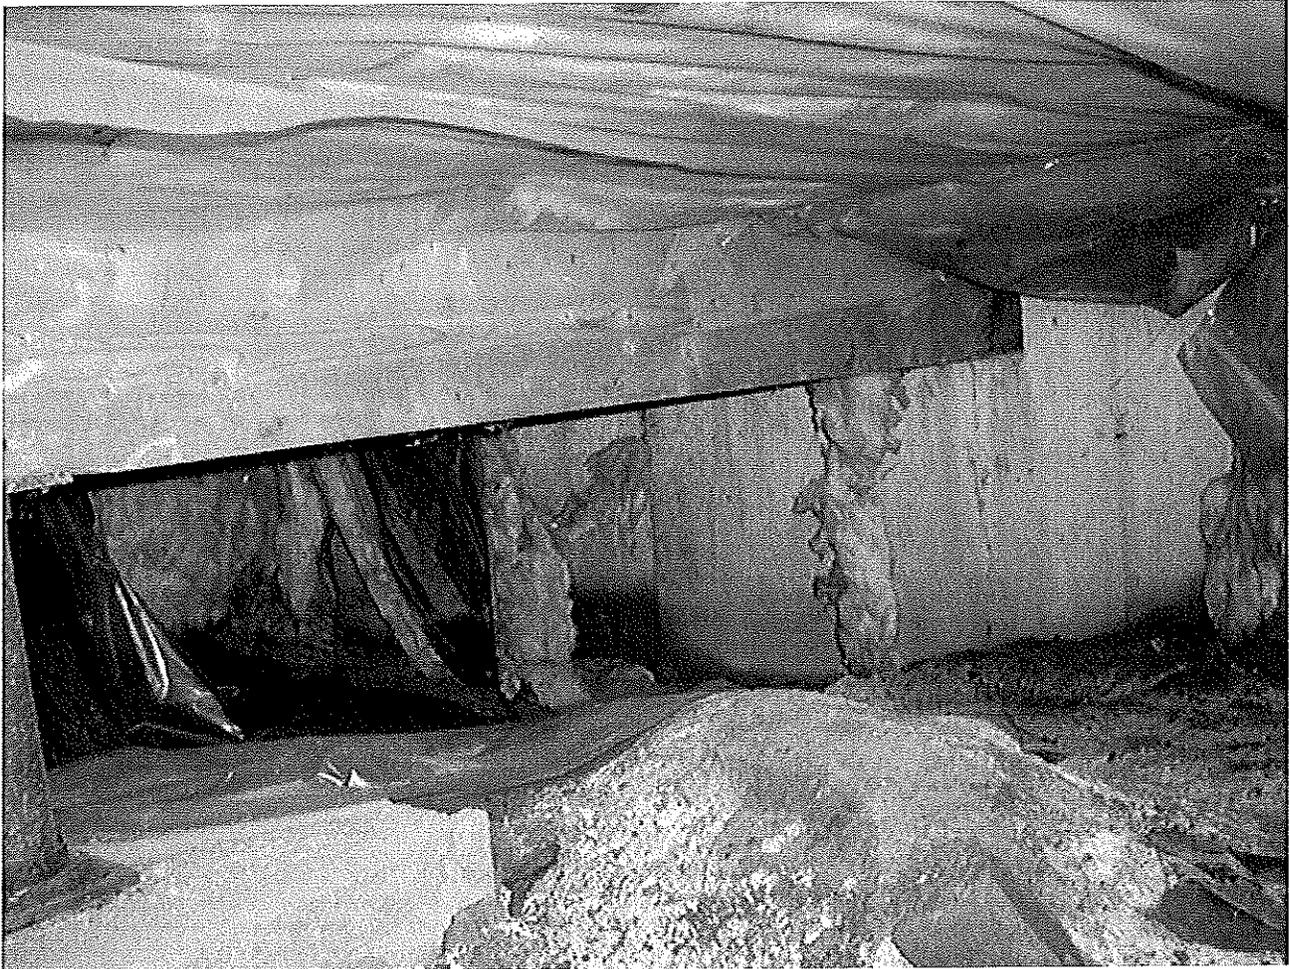
6 8321

East wall to left of the southeast corner, at the first beam pocket.

There appears to be a vertical crack from the left side of the beam pocket down to the footing. Beam end shows water staining.

Foundation wall at footing shows wetness from heavy rain five days ago.

White mold is on all exposed earth not covered by 4 mil poly ground moisture barrier.

4 mil poly stapled to joists is hanging, with insulation, possibly pulled down in a previous investigation of water damage. Note end of hanging kraft paper is wet.

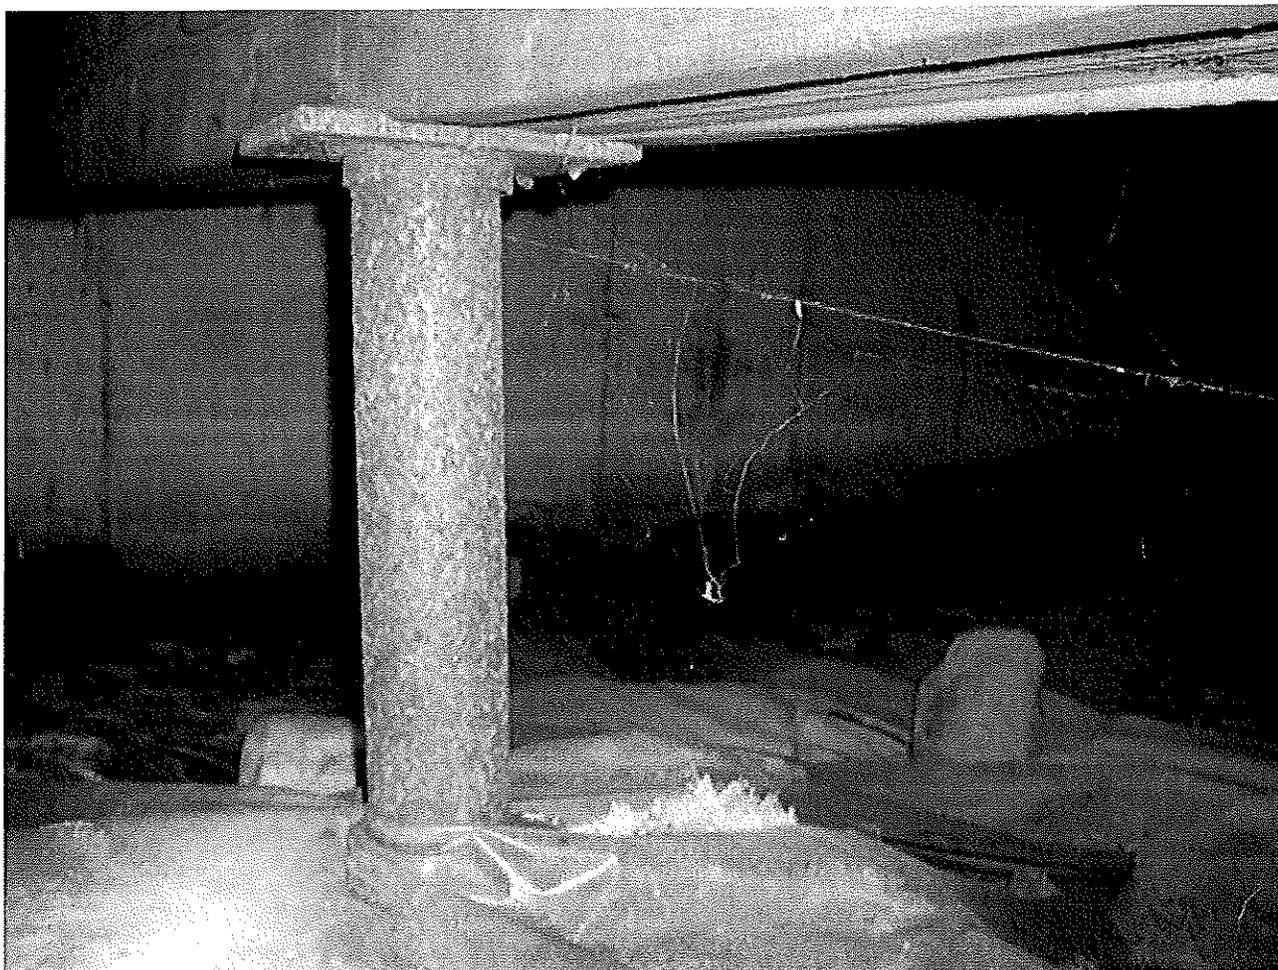
7 8324

East wall of the transverse crawl space, approaching the access panel.

Foundation wall at footing shows wetness from wicking ground moisture, and stain line from seasonal standing water.

All steel columns and plates are heavily rusted from condensation due to winter standing water and to summer humidity entering through the vents.

Note how 2x12s have crushed at bearing plate, possibly from long-term weight; but further investigation is recommended for early stage of dry rot.

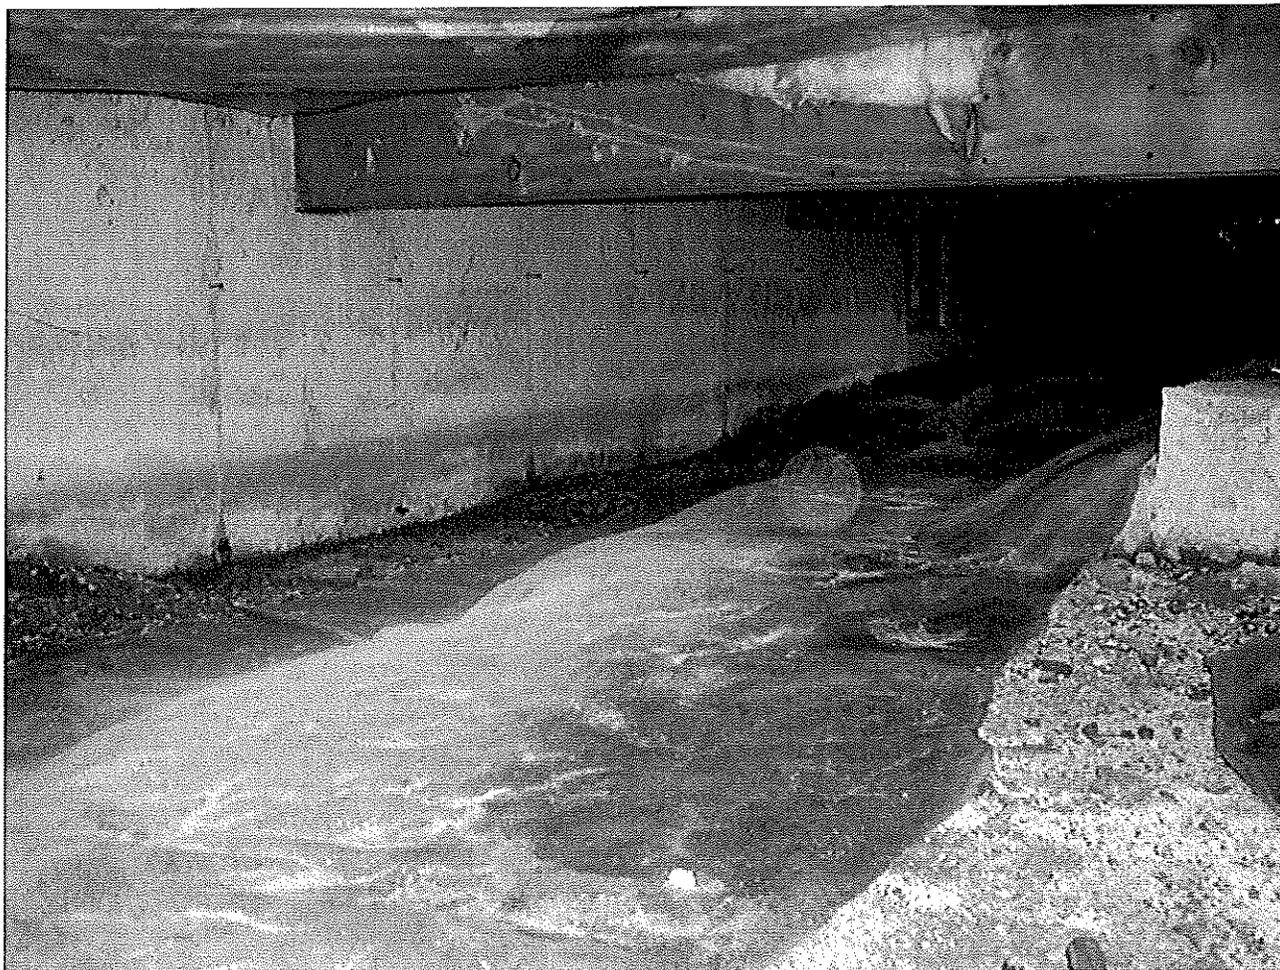
8 8326

East wall of the transverse crawl space, approaching the access panel.

Foundation wall at footing shows wetness from wicking ground moisture, and stain line from seasonal standing water.

White mold is on all exposed earth not covered by 4 mil poly ground moisture barrier.
